**CANADIAN FORCES
FLIGHT SAFETY INVESTIGATION REPORT (FSIR)**

FILE NUMBER: 1010-C-GCLY
DATE OF REPORT: 07 June 2002

AIRCRAFT TYPE: SZ 2-33A Glider
DATE/TIME: 10 June 2001 1715Z
LOCATION: Nanaimo Airport, Nanaimo BC
CATEGORY: "B" Category Accident

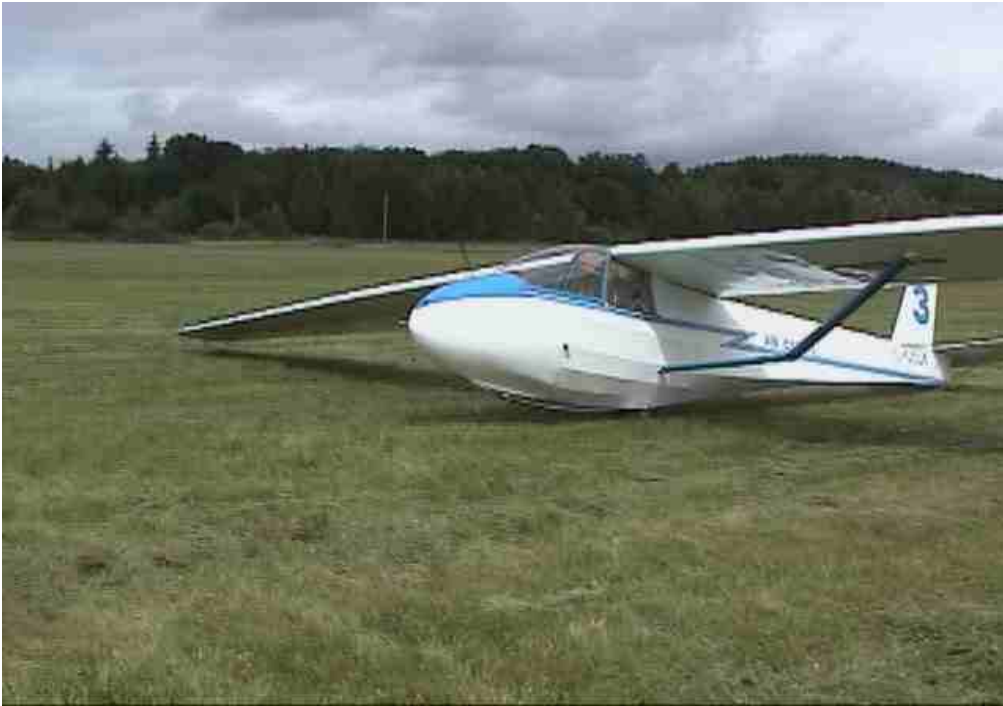
Glider shortly after landing

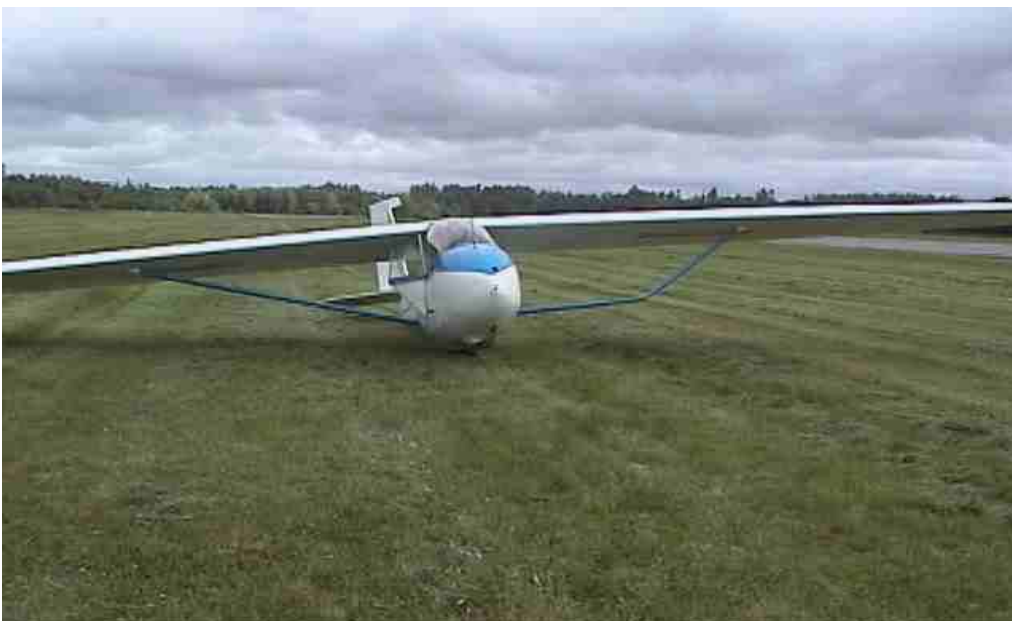
Front view of glider

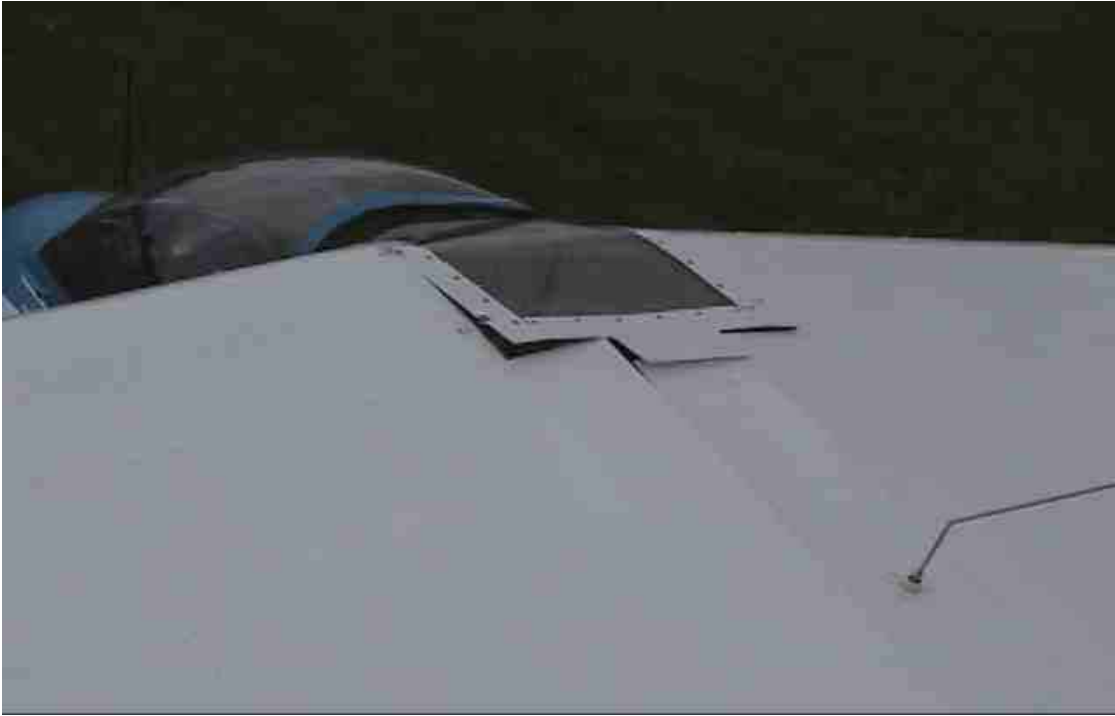
The LH wing strut is bent in the middle (not repairable). Both wings have substantial wrinkling on the bottom skins outboard of the strut attachments.

Top view showing skin buckling

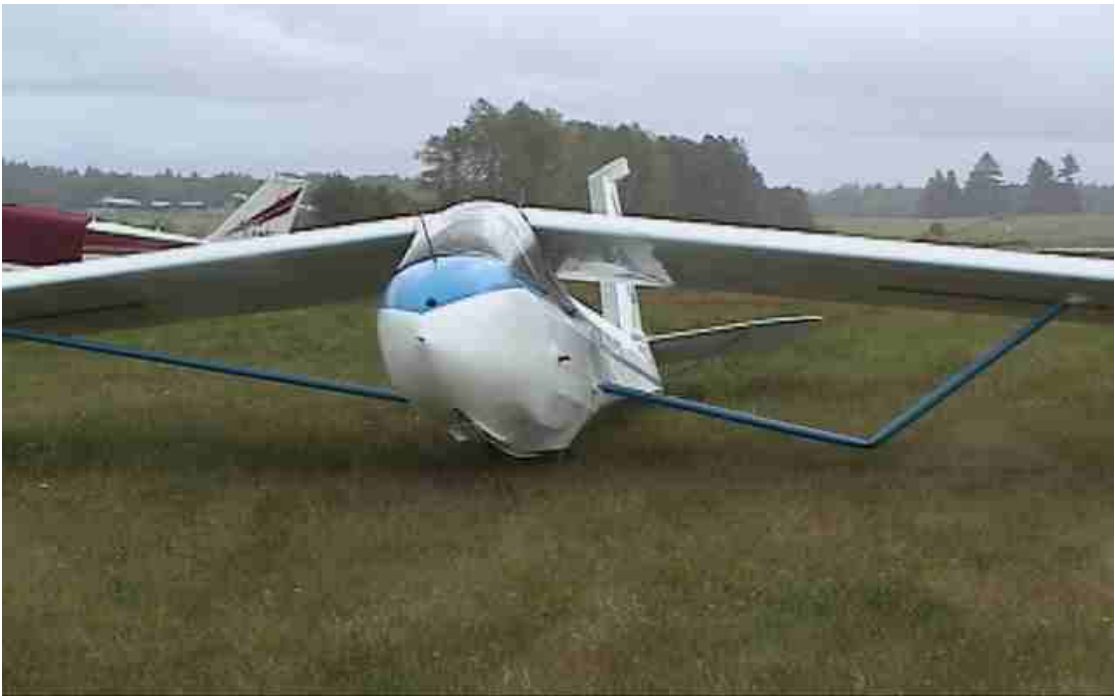
Glider after being towed to storage area
